**Point Roberts Beach Club
Lon Subdivision
(LSS 2007-00005)**

**ARBORIST RESPONSE TO
Whatcom County Planning
& Development Services
September 12, 2008 Letter
Sections A.4.B. & D, on Pages 3 & 4**

December 11, 2009

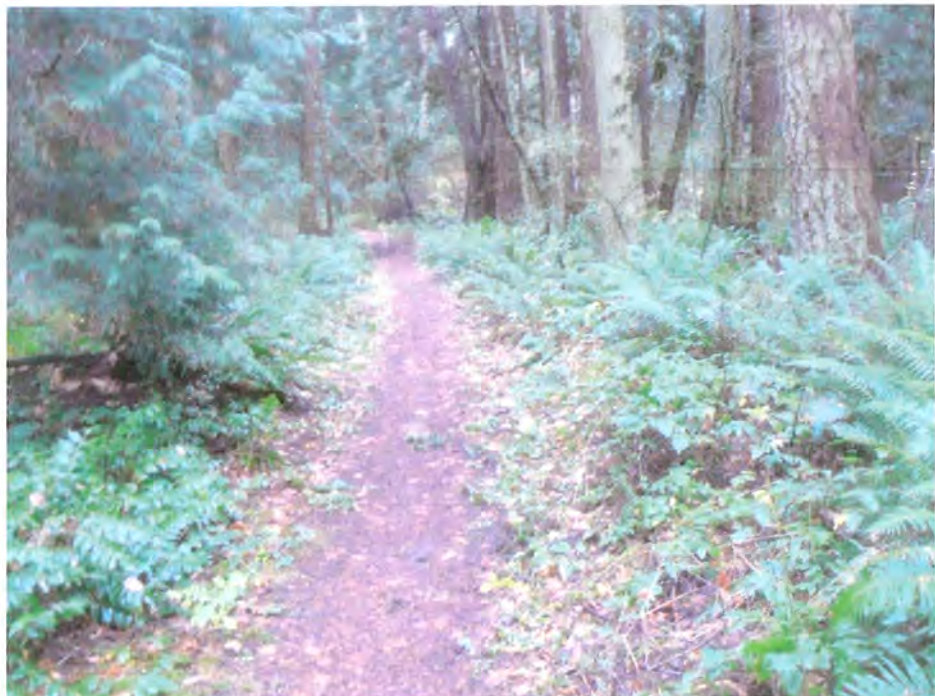
The northeast corner of the property where the septic system is proposed is primarily a dense forest of native tree species and associated shrubs and ground covers typical of the lowland Puget Sound region. Species are primarily Douglas Fir, Western Hemlock, and Western Red Cedar. There are a few Red Alder and Big Leaf Maple in the openings where there are no conifers.

The trees appear to be reasonably even aged and are possibly second or third growth. There is very little evidence of past logging activities in this portion of the property.

Photo # 1:
generic look at
the conifer
forest in the
northeast
corner where
the septic drain
field is being
proposed

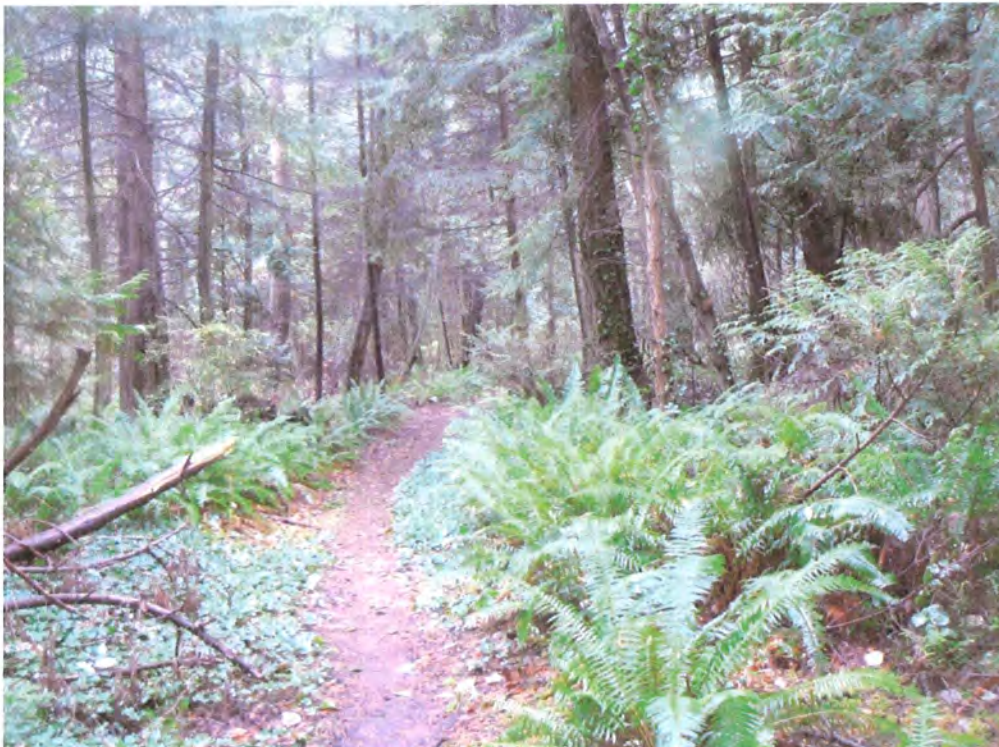
As noted above in the observations section, the forest appears generally to be in good health. If we look at tree conditions in 5 test plots of 100 square feet each, 70+% of the trees evaluated were rated as Fair, or Good. Details are seen in the chart below.

These numbers, showing the individual tree conditions, indicates that the majority of trees are capable of tolerating minor construction stress without undue concern for rapid decline.

Photo # 2:
Another view of the forest conditions in the northeast property corner
