Hannegan Road Scott Ditch Bridge No. 245 Replacement

Project Summary

November 2009

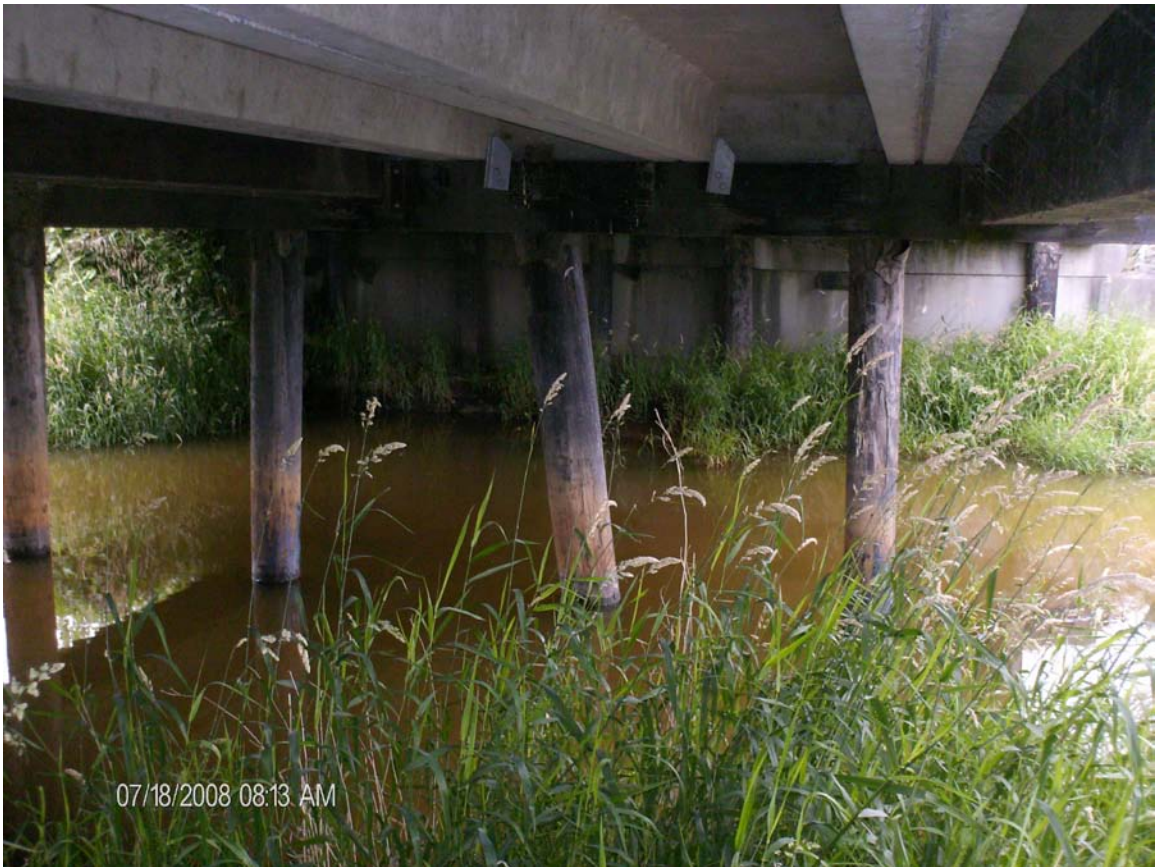
Looking north under the old bridge

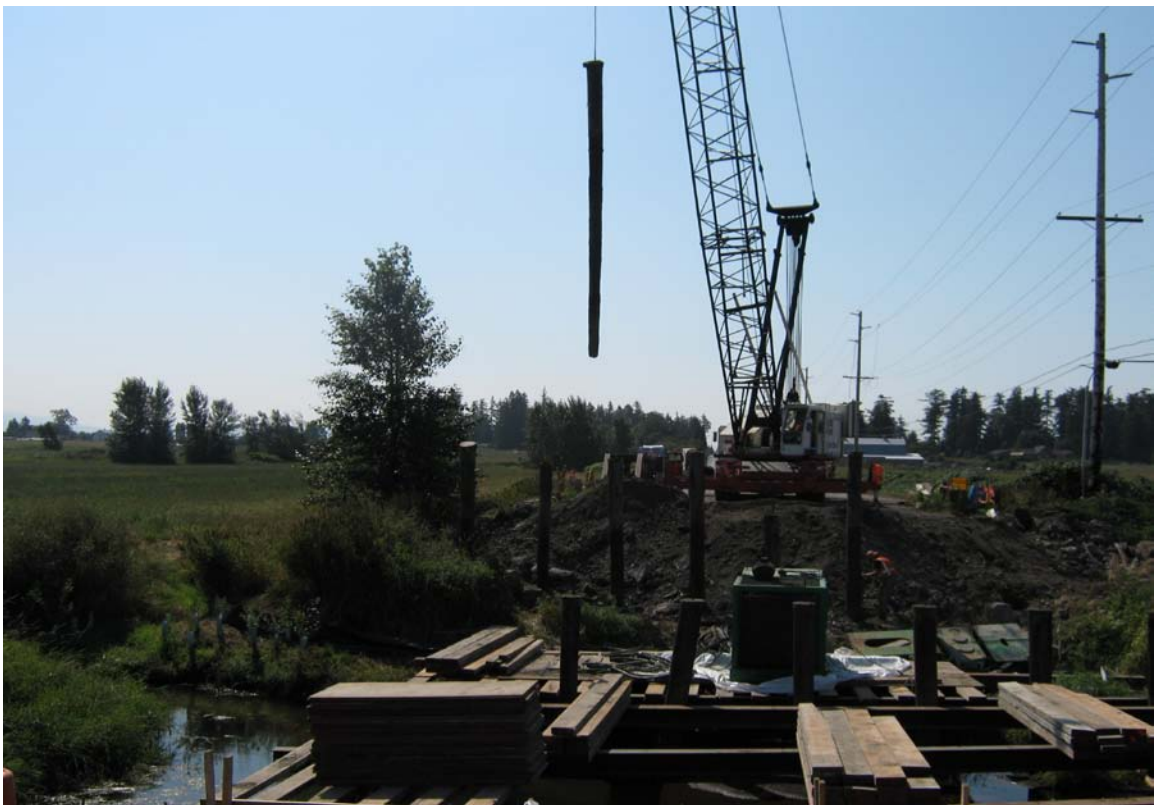
Removal of the old timber piles

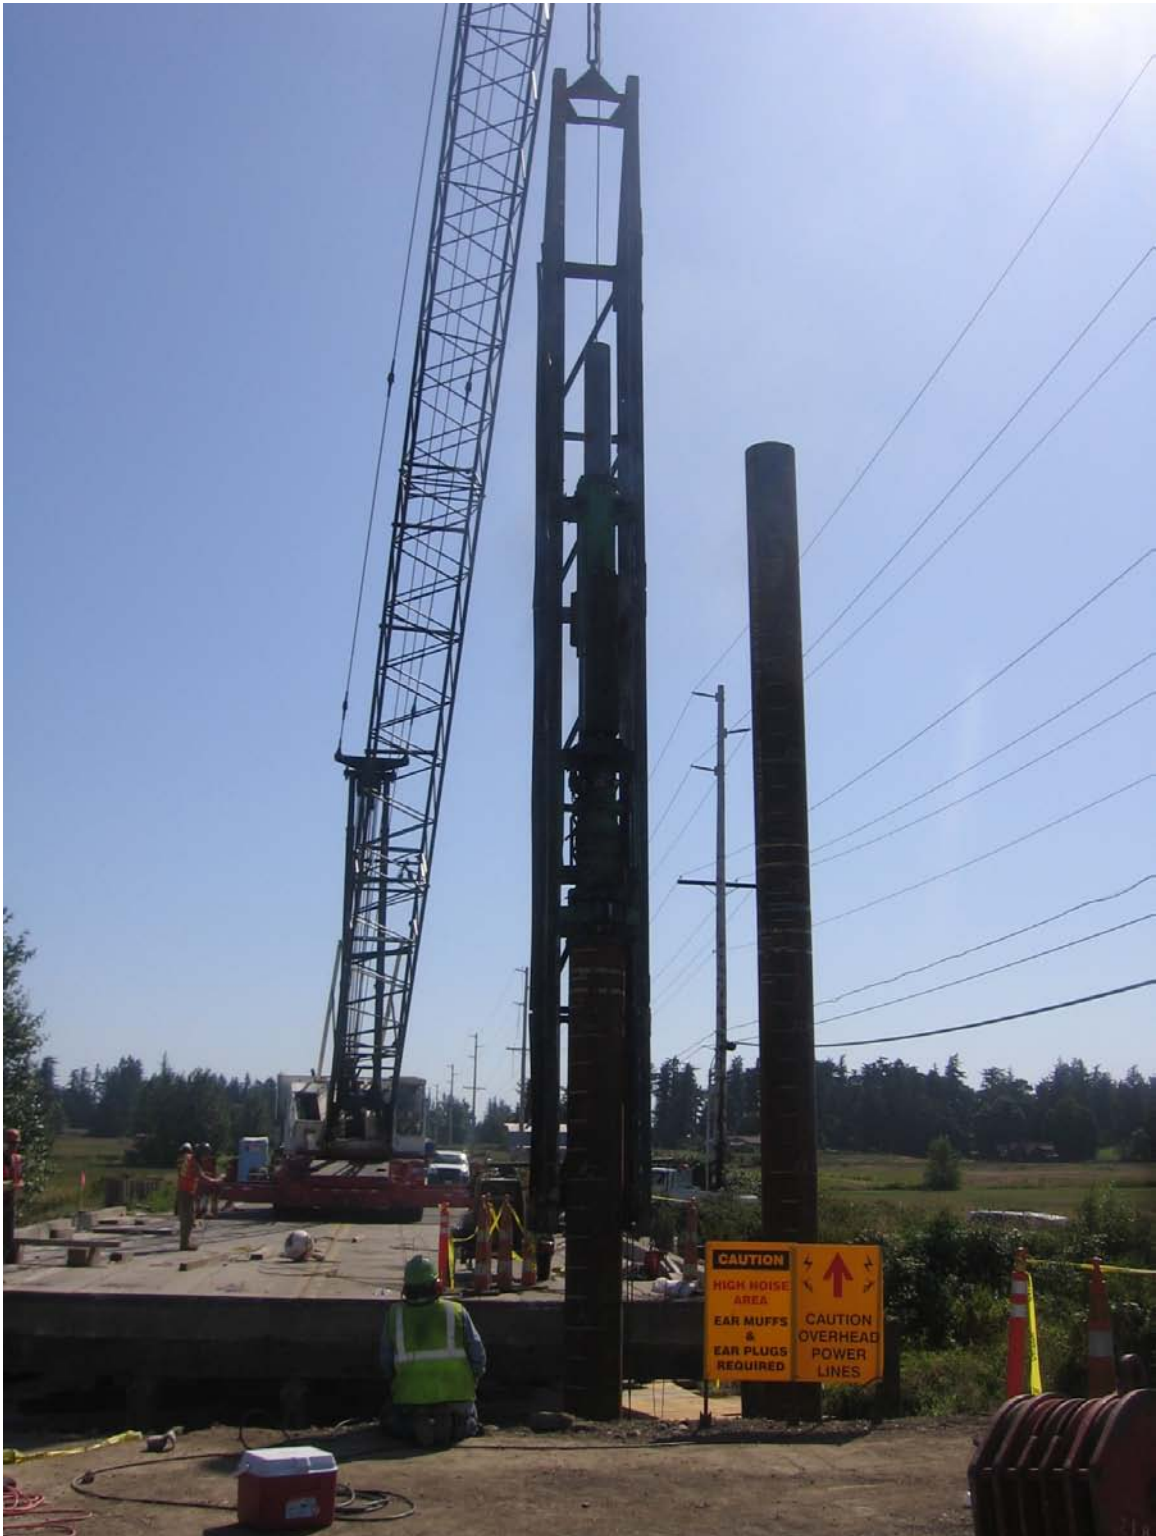
The piles for the new bridge are driven to 90 feet below ground and filled with reinforcing steel and concrete

Whatcom County Public Works proceeded with design and permitting of a replacement bridge during 2008. The replacement bridge was designed with cast-in-place concrete piles driven to 90 feet below ground and 70-foot prestressed concrete girders. In spring of 2009, Whatcom County was awarded \$600,000 of federal "stimulus" money toward the project. This was combined with \$400,000 of local money for a total project cost of approximately \$1,000,000.

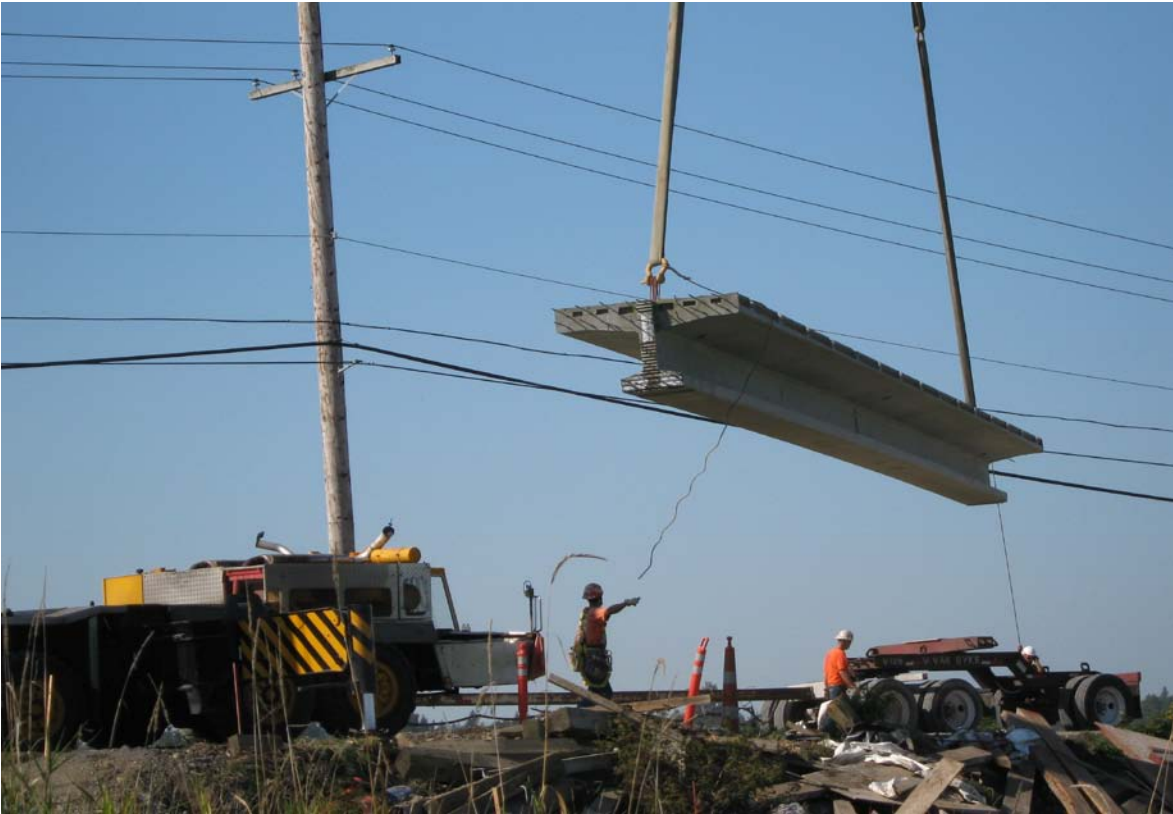
New bridge girder being set by a crane

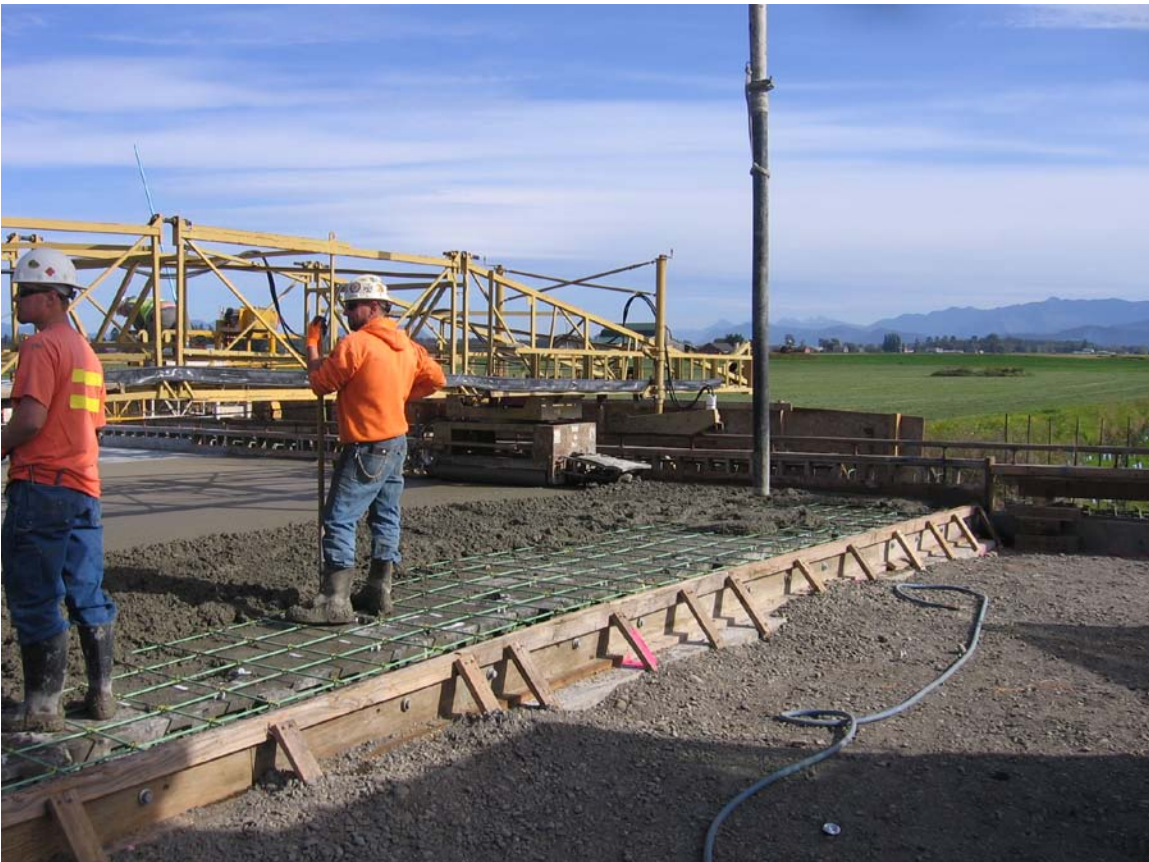
Casting the new reinforced concrete bridge deck on top of the girders

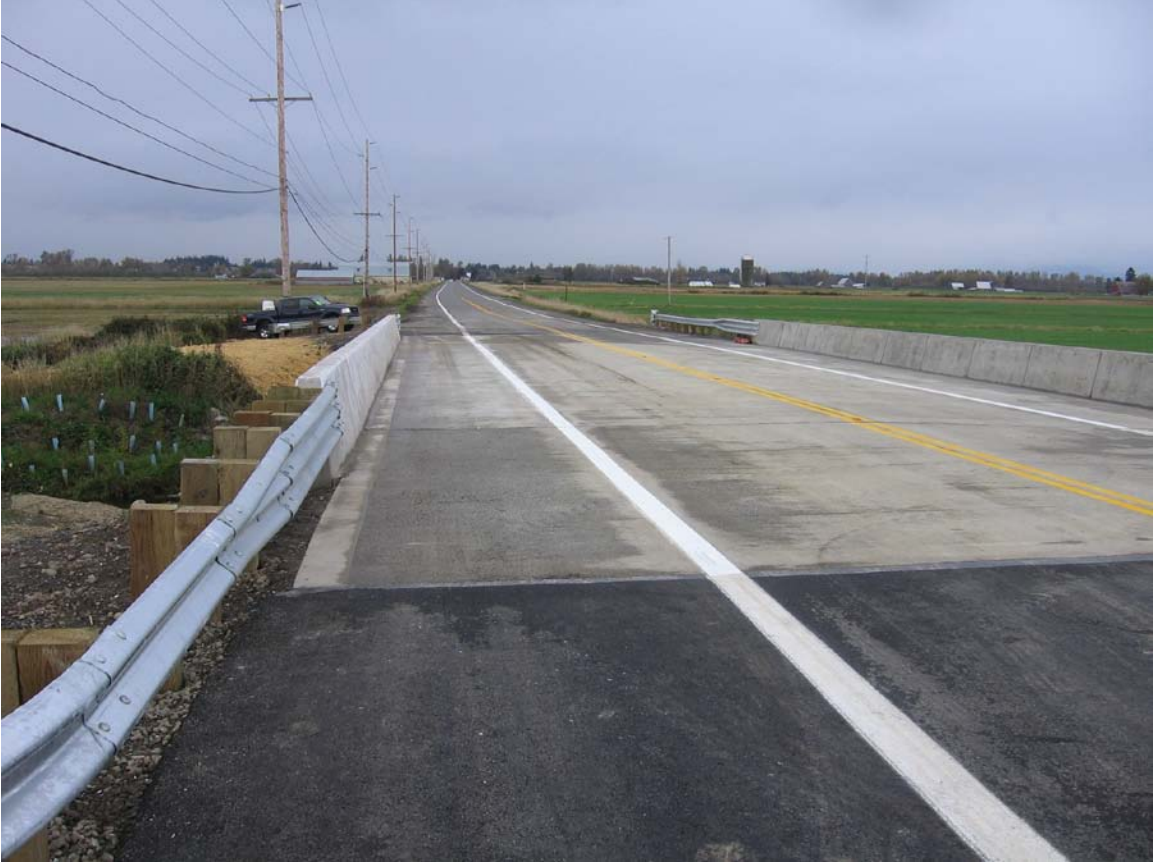
Looking north across the completed bridge
